VISUALIZING WATER QUALITY TRENDS IN CHIANG MAI RICE PADDIES: POSSIBLE LINKS BETWEEN ENVIRONMENT AND HEALTH RISKS

Amy M. Krueger and Kim N. Irvine
Department of Geography and Planning
Buffalo State, State University of New York
1300 Elmwood Avenue
Buffalo, NY 14222

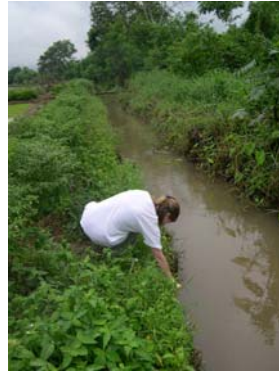
Figure 4. Bacteria sampling at Site 2, irrigation canal.

These sites were studied for a two week period. At each site, snails were sampled using hand collection in 4-m² plots for 10-minute intervals. Subsequently, the snails were taken to the lab, identified, and their parasitic infection was determined using crushing and shedding methods. On snail sampling days, a Hydrolab Datasonde 4a was used to collect water quality data for that particular day and time. These data included the temperature, dissolved oxygen (concentration and percent saturation), conductivity, turbidity, and pH of the water. During the second week, the Hydrolab was left in the irrigation canal at each site (1-3) for a 48-hour period to automatically log water quality data at 15-minute intervals. Water grab samples were tested for the presence of *E. coli* at each site/subsite, using Coliscan[®] Easygel[®] kits. At each subsite, 1-ml of water was collected, plated, and allowed to incubate at room temperature for 48-hours before bacteria colonies were counted. The physical environment (soil type, land use, topography, source water) was characterized in ArcView using various available digital layers, satellite images, and air photos.

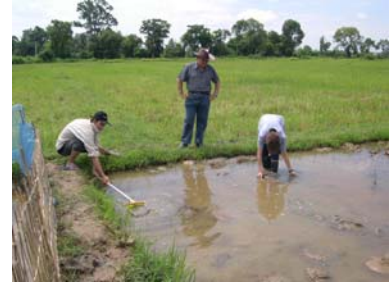
Figure 5. Snail sampling at Site 3, rice paddy.

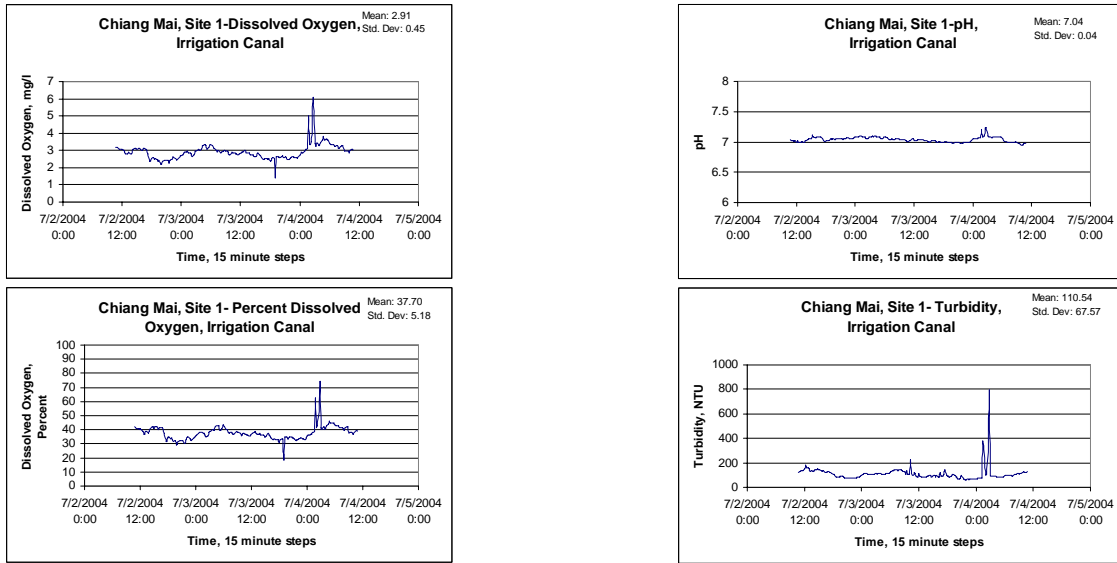
Figure 6. Hydrolab data (7/2/04 to 7/4/04) from the irrigation canal at Site 1.

Figure 6 (Continued). Hydrolab data (7/2/04 to 7/4/04) from the irrigation canal at Site 1.

To illustrate generally observed trends, results of the continuous Hydrolab monitoring for the Site 1 irrigation canal are shown in Figure 6. Results of the Hydrolab spot readings at each site are shown in Table 1. Results of the *E. coli* sampling are summarized in Figures 7 through 10.

Turbidity levels were greatest for storm events (e.g. 7/4/04, Figure 6) at all sites due to increased runoff and erosion. Higher bacteria levels also were associated with storm runoff. Conductivity decreased during the event of 7/4/04, representing a dilution of dissolved material. Similar dilution effects have been observed in rivers of North America and Hawaii (Irvine, 2003; Tomlinson and De Carlo, 2003; Irvine et al., in press). The storm runoff also increased oxygen levels (due to turbulent mixing and contact with the atmosphere) and decreased temperature in the canal.
