SPRING HOUSES OF MONTGOMERY TOWNSHIP, PENNSYLVANIA: HISTORICAL, LOCATIONAL, AND ARCHITECTURAL PATTERNS OF AN EARLY SETTLEMENT CULTURAL ARTIFACT

Dr. Alison E. Feeney and Brandon Snyder
Department of Geography and Earth Science
Shippensburg University, Shippensburg PA, 17257

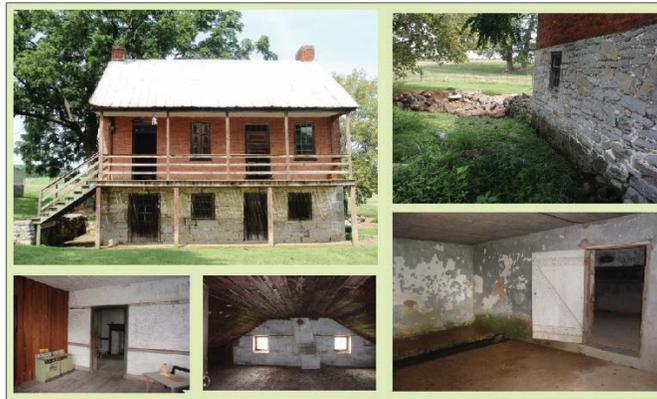
Figure 3: An example of a large spring house.

Figure 3 is an example of a large, detached spring house that measured 20 x 30 feet. The basement has two rooms with a trough of flowing water with ample room for cold storage and food preservation. The foundation walls have small slits possibly for ventilation or defense from Indian attacks, and the walls display evidence of high flood marks. The second floor contains a front kitchen with a fire place, a back bedroom, and a sitting room with another fire place. The stairs lead to a third floor loft, divided into two rooms. The cool basement is still used in hot summers, and the current tenants have not seen it dry up in over 50 years. On the other extreme, Figure 4 shows photographs from a small attached spring house. This house measures 7 feet wide by 7 feet 8 inches long, and it is attached to the basement of the main farm house. The upper right photo displays the house's foundation built directly into the fracture of the limestone rock, surrounded by tall grasses and flowing water. Inside the small spring house is a concrete trough, similar to the one in the large spring house, and a cup providing evidence of use.
