## **THE EFFECT OF ICE COVER ON SEDIMENT TRANSPORT CAPACITY AND STREAM CHANNEL MORPHOLOGY IN A REACH OF CAZENOVIA CREEK, NY**

Kelly M. Frothingham  
Department of Geography and Planning  
Buffalo State College  
1300 Elmwood Avenue  
Buffalo, NY 14222

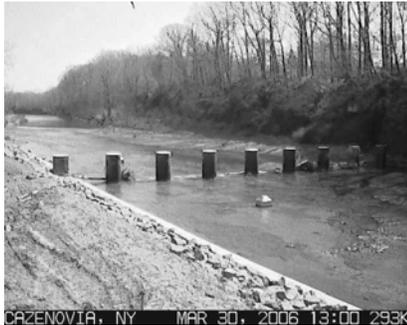
Figure 1. Cazenovia Creek ice-control structure.

The ICS consists of six 1.5 meter diameter cylindrical piers that are 3 meters above the average streambed elevation. The piers are spaced approximately 4 meters apart. The ICS is designed to block an ice jam and allow the ice to accumulate on the floodplain for storage to alleviate downstream flooding.

These frequent ice jams warranted construction of an ice-control structure (ICS) that was built upstream of this study's site during the 2005-2006 winter season (Lever et al., 2000) (Figure 1).

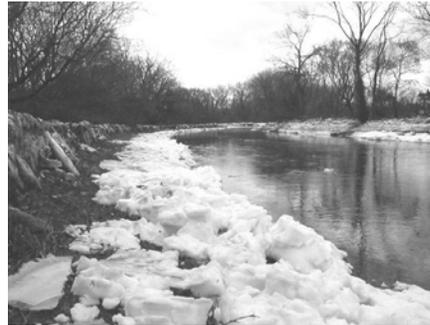
Figure 2. Streambank scour.

Figure 2 shows the USGS gage site after an ice jam breakup in December 2002. That event caused excessive bank erosion where 45-degree streambanks were sheared off by ice slabs to near-vertical banks.

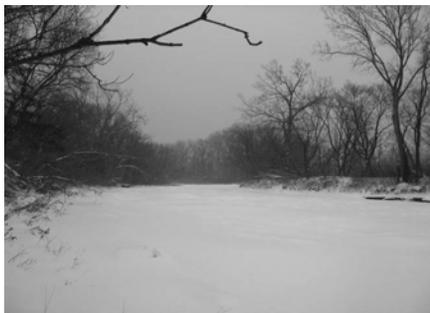
Figure 3. Winter 2005 field work.

Figure 3 shows the gage site with a free-floating ice cover in December 2005. The field team was preparing to collect data on ice thickness and water depth and velocity for a graduate student project associated with the current project.

During the course of this two-year project the Cazenovia Creek site experienced periods of ice cover (Table 1 and Figure 3); however, ice jams did not occur. The thickness of each ice cover was relatively constant (e.g., 3-4 cm thick) across channel cross sections and the ice covers were free-floating. In addition, it was noted that the ice melted gradually (e.g., over a period of days) starting in the center of the channel. Ice on the streambanks melted last, which appeared to protect the banks from erosion, and in some cases, blocks of ice accumulated on the streambanks, which further protected the banks from erosion.

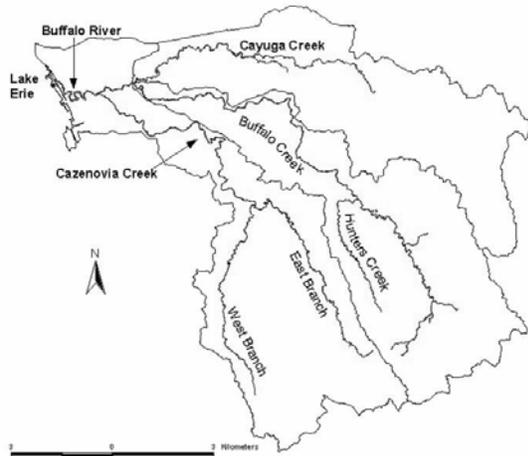
Figure 4. Cazenovia Creek and Buffalo River watershed.

Cazenovia Creek (Figure 4) is 48 km long and has a drainage basin area of 350 km<sup>2</sup>. The creek is one of three main tributaries to the Buffalo River. Cazenovia Creek has received a high prioritization for the identification of non-point pollution sources to improve water quality (Erie County Water Quality Coordinating Committee (ECWQCC), 2000) and silt-sized sediment from streambank erosion from upstream sources has been cited as the primary impairment in Cazenovia Creek (NYS DEC, 1996). Bank stabilization has been implemented in the creek in an effort to reduce sediment input from streambank erosion. Fourteen kilometers of Cazenovia Creek were part of a Natural Resources Conservation Service (NRCS) (formerly the Soil Conservation District) bank stabilization program in

The Buffalo River, NY watershed (Figure 4) has been severely impacted by human activity and sediment pollution has been a particular problem. This sediment pollution problem, as well as other

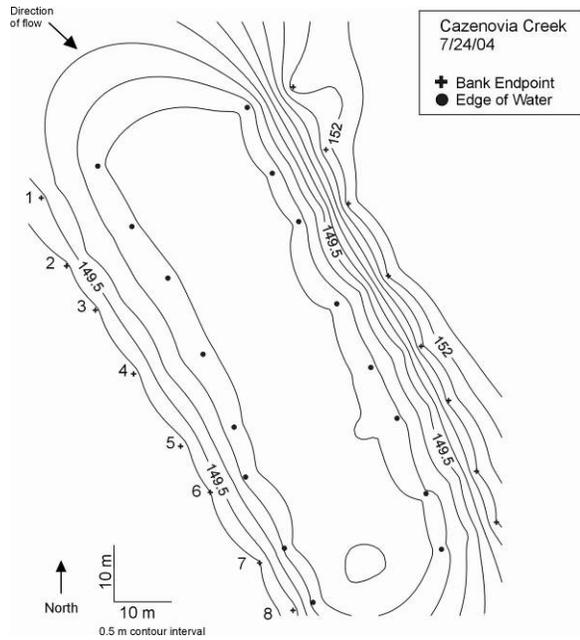
Figure 5. Cazenovia Creek morphology.

The Cazenovia Creek reach was approximately 80 m long and averaged 50 m wide (Figure 5). The reach was relatively straight and uniformly deep with a centrally located thalweg. Reaches in other ice cover studies, both in the field and in lab studies, had similar morphology (e.g., Ettema and Daly, 2004).

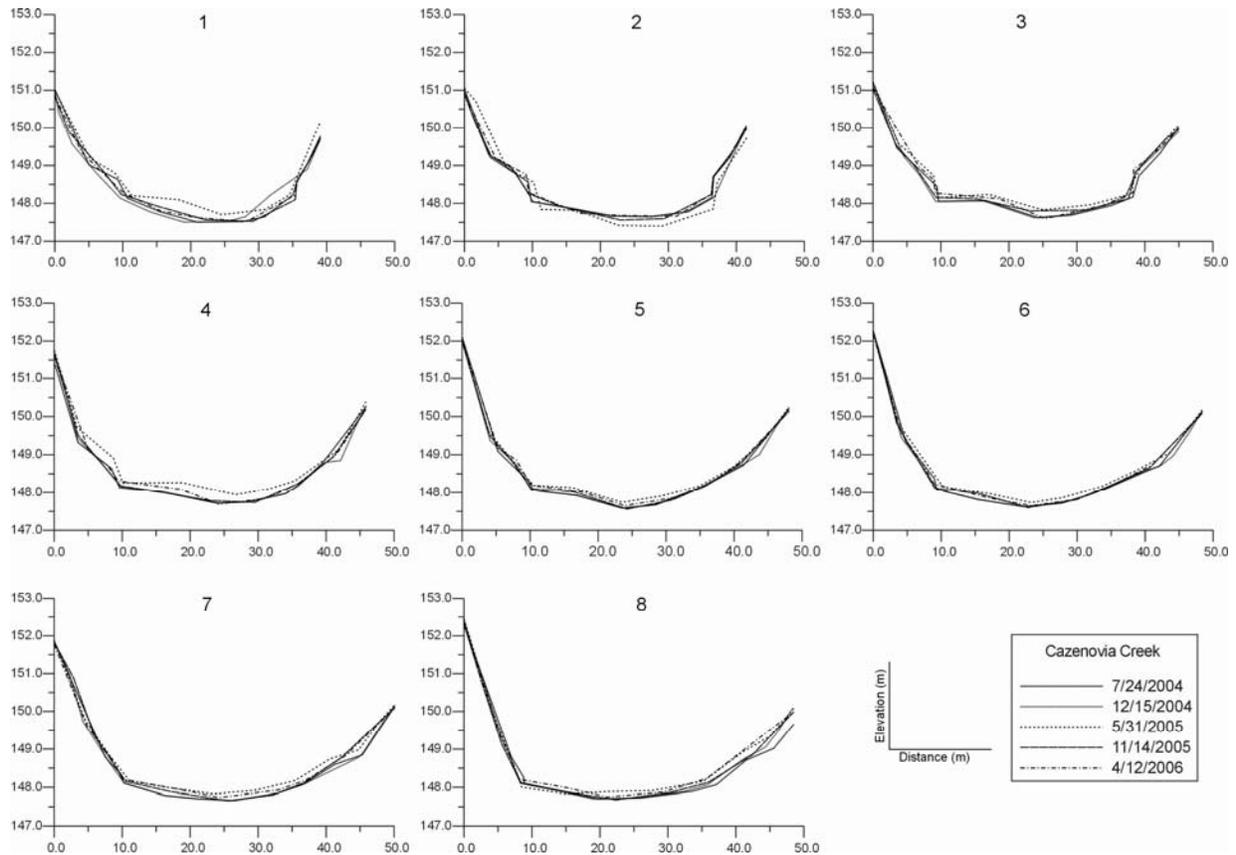
Figure 6. Surveyed cross sections.

Profiles of surveyed cross sections (Figure 6) indicate that overall change throughout the reach

was minimal during the study period. The upstream portion of the reach (cross-sections 1-4) showed greater relative change with as much as 25 cm point elevation change in a cross section. The downstream end of the reach was more stable; for example, less than 5 cm elevation differences along the west bank of cross-section 8.
