LOWER 9th WARD, NEW ORLEANS: RECOVERY AND REBUILDING

W. A. Lascell^{*} and P. R. Baumann
Department of Geography
State University of New York, College at Oneonta
Oneonta, NY 13820

ABSTRACT: *Hurricane Katrina, a Category 5 storm, struck the city of New Orleans on the morning of August 29, 2005 causing widespread destruction. Storm surges overtopped and breeched the levees meant to protect the city, flooding 80% of the city, with levels ranging from less than a foot to over 10 feet of water. The city remained flooded for over a month while the Army Corps of Engineers fixed the levees and pumped the water out of the low-lying landscape. Neighborhoods were forever changed as a painstakingly slow recovery forced long-time residents to make difficult decisions about where to live. The Lower 9th Ward residential neighborhood is probably the most extreme example of the change Katrina caused in the city of New Orleans. Using aerial photography, satellite imagery, ground data and fieldwork, this paper explores Katrina's impact on this geographically vulnerable residential neighborhood and the issues associated with its recovery and rebuilding.*

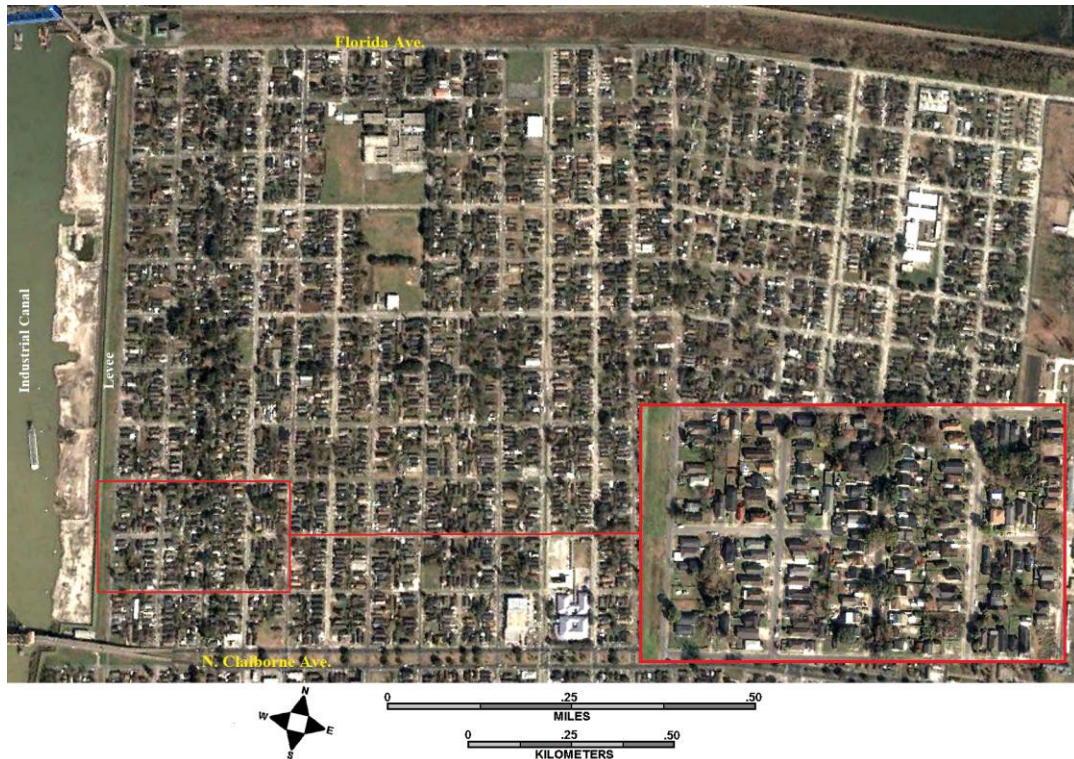
Figure 3: Lower 9th Ward: February 6, 2003 (DigitalGlobe QuickBird).

Figure 3 (2003 QuickBird satellite imagery) shows the Pre-Katrina conditions within the study area. The inset provides a better view of the detail level of the imagery. The Ward consisted of detached, small, single-family homes with a grid street pattern. The most common type of home was the one-story Shotgun Style house although some multistory houses existed. Small green spaces were found on many lots and mature trees lined several blocks. The levee acted as a floodwall, holding back the water from the Industrial Canal. A small, sloped grassy area was all that separated the levee wall from the residential properties. Schools, churches, and grocery stores were all in the vicinity of the neighborhood. The High School can be seen in the northwestern corner of the image, just below Florida Avenue. The building lots were generally small in area and long and narrow in shape, relating to the Shotgun Style house. The high density of houses (2,051 per mi², 778 per km²) that existed before Katrina related to the high population density (5,347 per mi², 2,029 per km²) (U.S. Census Bureau, 2000). The inset image in Figure 3

illustrates these conditions. The shape and dimension of these lots created issues during the recovery process. Replacement homes were limited in design and function to these lots and trying to consolidate lots to handle larger activities created political and legal issues.

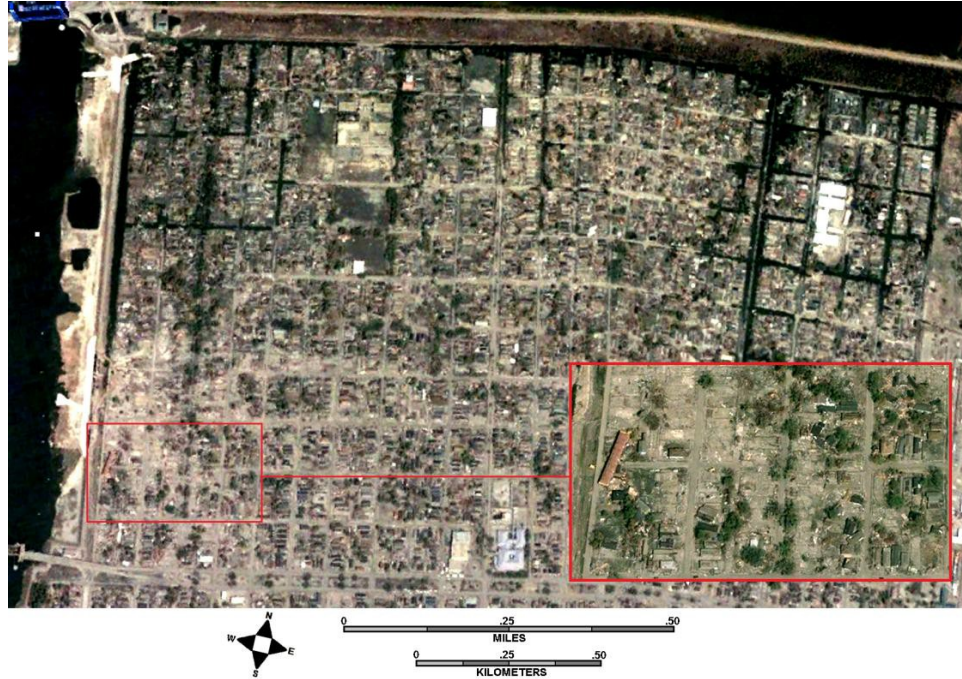
Figure 4: Lower 9th Ward: September 20, 2005 (DigitalGlobe QuickBird).

Figure 4 shows the Ward between Hurricane Katrina and Hurricane Rita. Rita came across Louisiana on September 24, 2005, four days after the satellite image (Figure 4) was taken. The most severely damaged section of the Ward was just north of Claiborne Avenue. The Figure 4 inset image clearly shows the barge that was initially thought to have created the gap in the levee but was later determined to have been drawn through an existing hole in the floodwall and crushing a number of structures and a school bus. Due to liability issues the removal of this barge required court action. Salvage work started in February 2006 and was completed by the end of March 2006. Thus, the barge does not appear in Figure 5, an oblique aerial photograph taken on June 6, 2006.

As can be detected in Figure 4 the N. Claiborne Avenue site had been pumped dry but water remained on

the north side of the Ward, near Florida Avenue, where the lowest elevations (-14 feet, -4 km) exists. Although the major breach occurred near the Industrial Canal, several other breaches existed along the Florida Avenue levee. The dark water/street patterns that run perpendicular to the Florida Avenue levee identify where the storm surges came across the Main Outlet Canal. It took over a month for the Army Corps of Engineers to repair the levees and pump out the floodwaters.

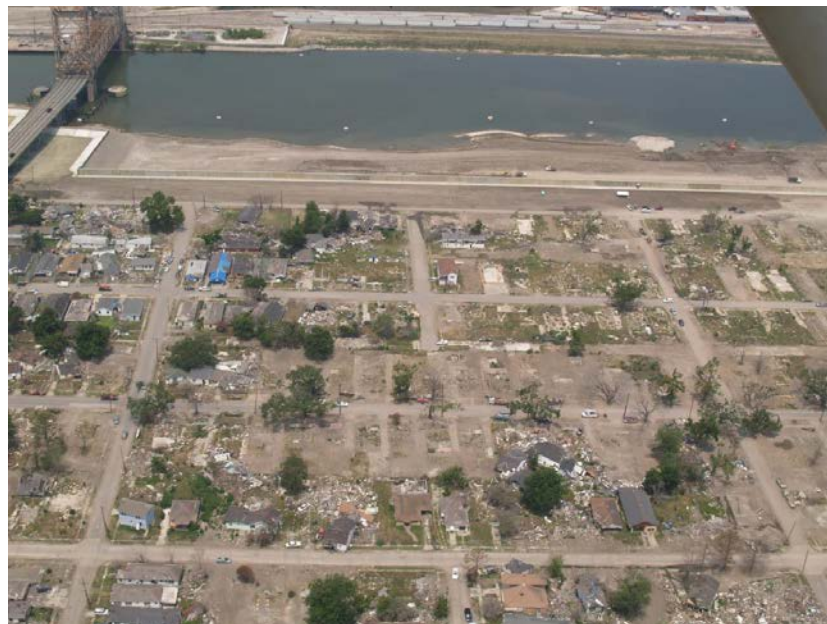
Figure 5: Oblique aerial photograph of a portion of the study area. N. Claiborne Avenue is to the left of the image, the Industrial Canal and the levee is at the top of the image. This photograph corresponds to a section of the Figure 4 inset. (Photo taken by Wendy A Lascell, 2006).

Figure 5 shows the damage near the N. Claiborne Avenue levee breach. Some houses remain on their foundations while others were destroyed by the storm surge – no major demolition of homes had occurred at this point in time. A Bring Back New Orleans Commission Executive Summary Report (2006) suggested making this area in whole or part into park space because of the high risk of future flooding. Most Ward residents strongly objected to this proposal, but outside experts worry about the high risk of future flooding in the area.

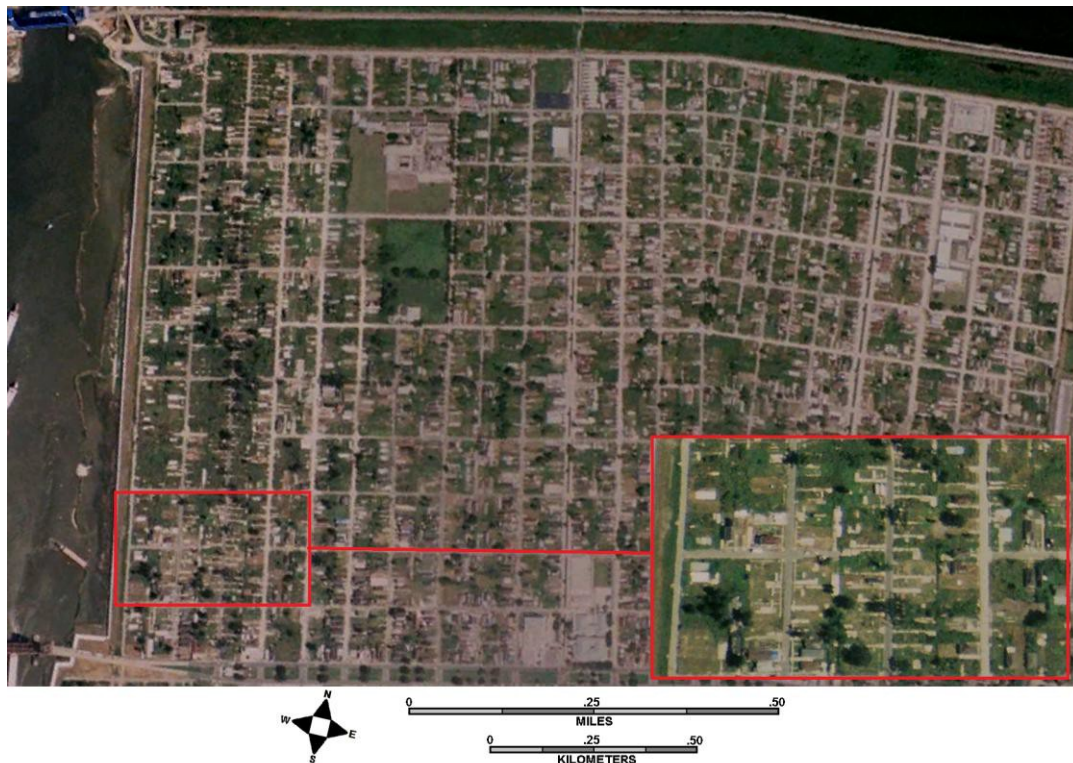
Figure 6: Lower 9th Ward: October 11, 2007 (DigitalGlobe QuickBird).

The 2007 high resolution satellite image (Figure 6) shows the streets being cleared of debris and a great number of concrete slabs on which houses and other structures had been built are exposed. Any rebuilding will require in most cases the removal and disposal of these slabs, a time consuming and costly endeavor. Hundreds of

these slabs as well as paved driveways are distributed across the landscape. Many houses were not built on concrete slabs. They were constructed slightly off the bare ground by using concrete blocks as pillars. These areas are now covered with tall grass and weeds and occurred over large sections of the Ward. Overgrown vegetation is associated with abandoned lots. Some abandoned lots have been maintained by neighborhood residents and volunteers working with *Common Ground Relief*, a grassroots, non-profit organization born the day after Hurricane Katrina occurred. Other empty lots seen on the image were not abandoned and were being maintained by property owners. Houses can be detected but little evidence exists that any major recovery endeavor has taken place.

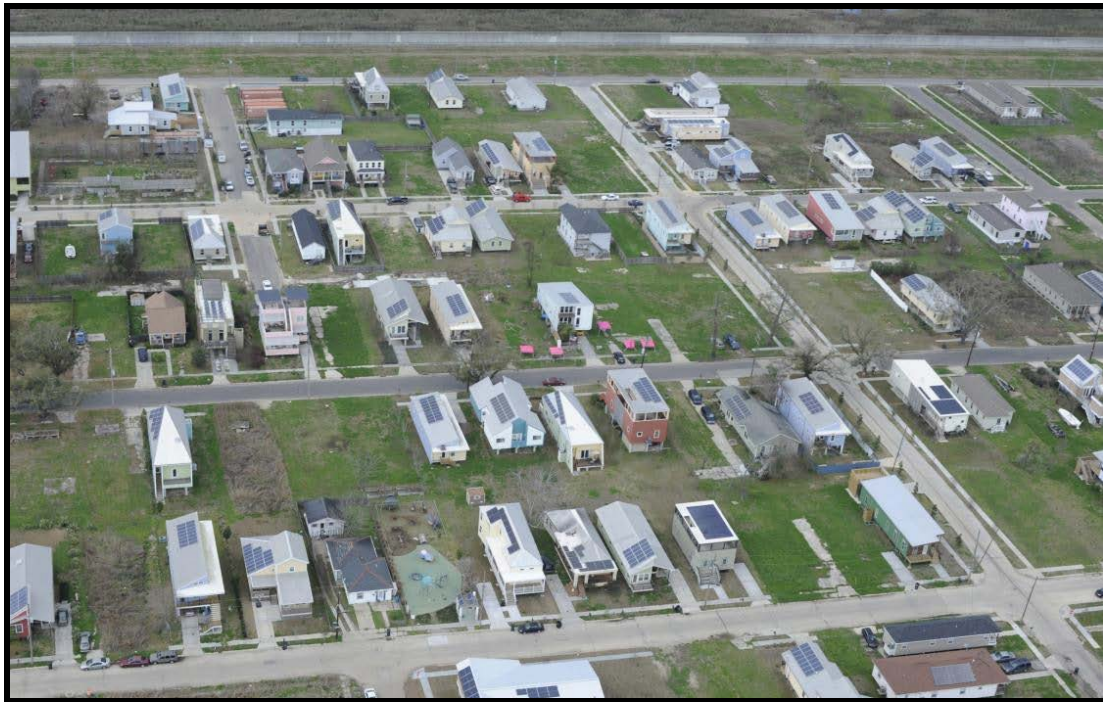
Figure 8: Homes with solar panels built by the *Make It Right Foundation*, other were pre-existing and renovated by homeowners many with the help of *Common Ground Relief*. The headquarters of both non-profits are located within the image area. Claiborne Avenue is to the left of the image just out of view, the Industrial Canal levee is at the top of the image. (Photo taken by Wendy A Lascell, 2015).

In the period between 2007 and 2014, several non-profit agencies were established to renovate and rebuild properties in the Ward. One of the first non-profits was *Common Ground Relief*. It centered on gutting and renovating pre-existing properties. It placed a heavy emphasis on using volunteers working along with homeowners (Figure 9). *Make It Right*, the Brad Pitt non-profit founded in 2007, focused on new builds with green construction standards and elevated structures to mitigate future flood events. In the 2015 Low Oblique aerial photograph (Figure 8) 42 new homes with solar panels on rooftops can be detected. Solar panels did not exist in Ward prior to the *Make It Right* builds. These are all new single-family homes. *Make It Right* has plans to build a total of 150 homes, shifting the Ward's appearance from its historical roots of ground-level Shotgun Style architecture to modern, green aesthetic structures. The one characteristic that *Make It Right* preserved in its homes was the colorful

nature of houses. In the spring of 2008, *Build Now*, a local, non-profit homebuilder, began working to bring New Orleans families back home. He is constructing site-built, stilt houses. The homes reflect the style and quality of traditional New Orleans architecture but are built above potential flood waters. *Build Now* is in the process of bringing more than a dozen New Orleans families back home; nine houses are currently under construction in the Ward. The organization has moved three New Orleans families back home. As shown in Figure 10, the Ward has changed dramatically since before Hurricane Katrina altered the landscape, now occupied by a combination of approximately a dozen renovated pre-existing homes, approximately 100 *Make It Right* green homes, and many empty lots. However, with cheap housing largely destroyed, housing prices have skyrocketed by 43%. Public housing projects were demolished and replaced with lower-density housing (Greater New Orleans Inc, Regional Economic Development, 2015). No new public housing projects are planned for the future in the Ward.

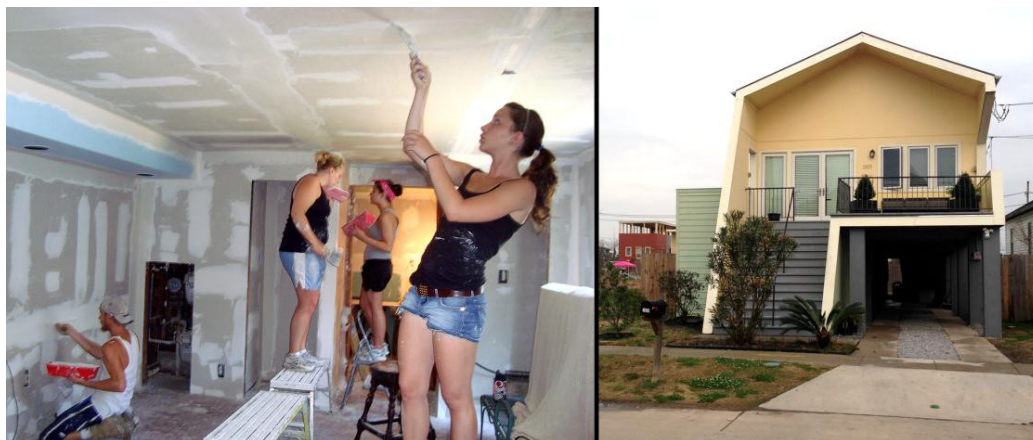
Figure 9: *Common Ground Relief* volunteers doing rehab work on existing home (left); *Make It Right* newly constructed home (right). (Photos taken by Wendy A Lascell, 2010 and 2015).
