USING THE STREAM VISUAL ASSESSMENT PROTOCOL (SVAP) AS A MONITORING TOOL TO ASSESS STREAM CORRIDOR CONDITIONS OVER TIME

Kelly M. Frothingham^{*1} and Amy M. Bartlett² ¹Geography and Planning Department Buffalo State College Buffalo, NY 14222 ²ERIE Program University at Buffalo Buffalo, NY 14260

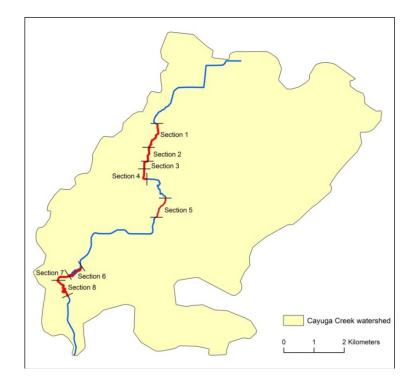
Figure 2. Cayuga Creek watershed map with study sections identified.

The length of each reach and, therefore, the total number of reaches assessed varied slightly between 2004 and 2008 (Table 2). A total of 44 stream reaches were assessed in 2004 (Frothingham and Brown, 2005) and 53 reaches were assessed in 2008 (Frothingham et al., 2009). As a result of the different reach lengths, it was not possible to compare overall and individual element SVAP scores in each reach as they were defined in 2004 and 2008; therefore, reaches were combined into eight sections using the reach length data and photo indexes from 2004 and 2008 (Frothingham et al., 2009; Frothingham and Brown, 2005) (Table 2; Figure 2). Stream Section 1 was located in the upper portion of the watershed and the sections progressed in the downstream direction (Figure 2). The reach element and overall scores were averaged for each section and compared.

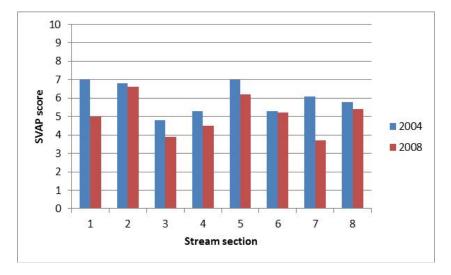
Figure 3. Overall Stream Visual Assessment Protocol scores for the stream sections in 2004 and 2008.

The 2004 and 2008 SVAP scores by study section for the overall and element scores are in Table 3. The 2004 and 2008 overall SVAP scores for all the sections were not statistically different at the $\alpha = 0.05$ level (U = 15, p = 0.083) (Table 3; Figure 3). All the overall SVAP section scores were low (\leq 7.4; a fair SVAP rating) (see Table 1) and 63% of the sections (Sections 3-4 and 6-8) had SVAP scores in both years that were less than 6.0, which is a poor SVAP rating.

showed that the overall scores were not significantly different between 2004 and 2008 (Table 3; Figure 3), which was expected given the fact that major watershed changes did not occur between 2004 and 2008.

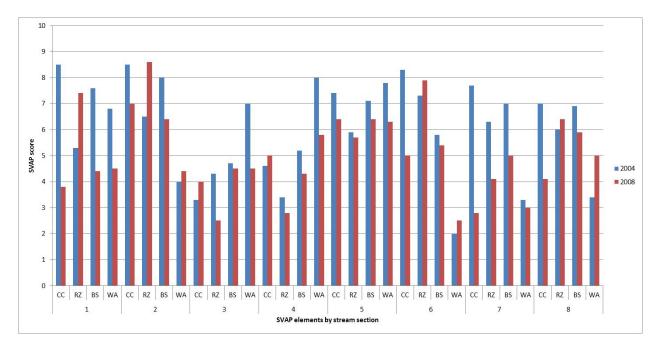
Figure 4. Stream Visual Assessment Protocol element scores for the stream sections in 2004 and 2008. CC = Channel Condition; RZ = Riparian Zone; BS = Bank Stability; WA = Water Appearance

The 2004 and 2008 channel condition SVAP scores were significantly different (U = 11.5, p = 0.028) (Table 3; Figure 4). In Sections 1, 6, and 7 the average channel condition scores were relatively high (8.5, 8.3, and 7.7, respectively) and decreased in 2008 to low scores (3.8, 5.0, and 2.8, respectively) (see Table 1). Average bank stability scores were also significantly different (U = 12, p = 0.038) (Table 3; Figure 4). Most (75%) of the section bank stability scores were low (\leq 7.4) in both years; however, in Sections 1 and 2 the scores decreased from 7.6 and 8.0 in 2004 to 4.4 and 6.4 in 2008, respectively (see Table 1). Conversely, riparian zone and water appearance scores from 2004 and 2008 were not significantly different (U = 30, p = 0.878 and U = 26, p = 0.574, respectively) (Table 3; Figure 4). Overall, the riparian zone and water appearance section scores were low (\leq 7.4) (see Table 1) and similar in both 2004 and 2008.

Individual element scores (e.g., channel condition, riparian zone, bank stability, and water appearance), however, showed greater variability (Table 3; Figure 4). Based on working in the watershed and a thorough review of the 2004 and 2008 field sheets and photo indices, we believe that the differences noted from the statistical analysis were not due to actual changes in stream corridor conditions, rather the differences are likely attributable to training and the relative ease of assessing each individual element. Other studies have attributed differences in SVAP scores to variability in crew member training and experience with stream assessments (Hughes et al., 2010; Bjorkland et al., 2001). The ease of assessing individual SVAP elements has been addressed in the updated SVAP2, as that protocol "was developed to provide more comprehensive descriptions of several scoring elements" (NRCS 2009, pg. i).
